DEPARTMENT OF TRANSPORTATION

Contract #: 04-0120F4Cty: SF/ALA Rte: 80 PM: 13.2/13.9File #: 69.28**WELDING INSPECTION REPORT****Resident Engineer:**Pursell, Gary**Address:** 333 Burma Road**City:** Oakland, CA 94607**Report No:** WIR-014538**Date Inspected:** 18-May-2010**Project Name:** SAS Superstructure**OSM Arrival Time:** 700**Prime Contractor:** American Bridge/Fluor Enterprises, a JV**OSM Departure Time:** 1900**Contractor:** Zhenhua Port Machinery Company, Ltd (ZPMC), Changxing Island **Location:** Shanghai, China**CWI Name:** Xu tao / Zhou cheng**CWI Present:** Yes No**Inspected CWI report:** Yes No N/A**Rod Oven in Use:** Yes No N/A**Electrode to specification:** Yes No N/A**Weld Procedures Followed:** Yes No N/A**Qualified Welders:** Yes No N/A**Verified Joint Fit-up:** Yes No N/A**Approved Drawings:** Yes No N/A**Approved WPS:** Yes No N/A**Delayed / Cancelled:** Yes No N/A**Bridge No:** 34-0006**Component:** OBG Components**Summary of Items Observed:**

WELDING INSPECTION REPORT

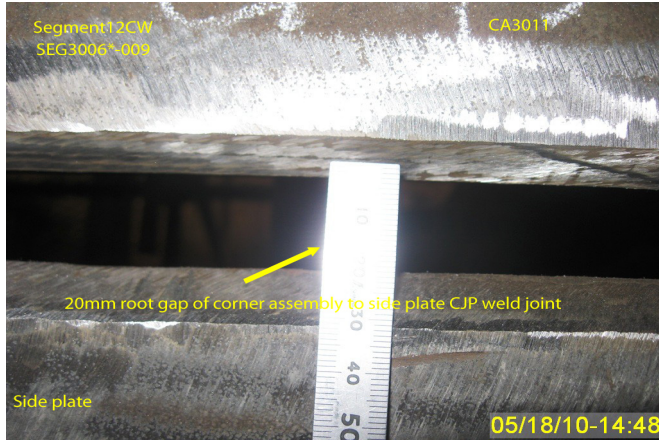
During in process inspection it is found that in segment 12CW by Visually the weld joint fit-up of Corner assembly to side plate complete joint penetration weld has 10~20mm root gap those location marked and informed to ZPMC QC Mr. Xu tao , he agreed and will arrange WR for the repair work.

During in process inspection it is found that in segment 12CW by visually the weld joint fit-up of Floor beam flange is identified as FB3096 to Corner assembly flange is identified as CA3011 at PP116.5 (south side) misaligned 10mm. ZPMC not yet start any welding. They have sent this issue to their Technical engineer for further fabrication.
